TECH TIP

ROTAX
RACING

02 Multiple Function Switch Update

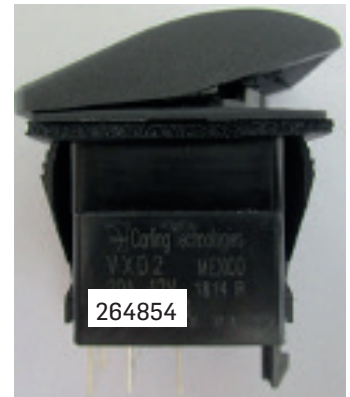
1 - MULTIPLE FUNCTION SWITCH

Grease isolating the contacts, inside the switch, causing the failure. (engine start problems, possible engine misfire)

Procedure to fix a failed switch:

- › Replace defective switch with a new switch:
New switch must be marked with the number "264854".
- › Removal of grease from the connector
The removal of grease is only valid for the connector of the switch, not for any other connector of the wiring harness!

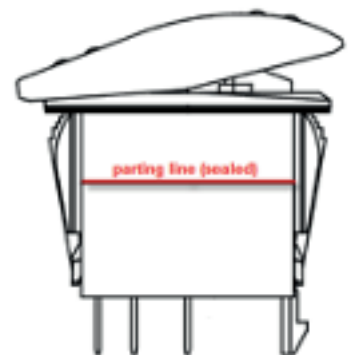
2 - SWITCH SEALING

The switch must not be opened!

- › The switch is sealed on the parting line to prevent water intrusion.
- › By opening the switch this will break the sealing which can cause failure and warranty becomes void.
